DURABILITY OF CULVERT PIPE

Jas. H. Havens  
Director of Research

Division of Research  
DEPARTMENT OF HIGHWAYS  
Commonwealth of Kentucky

August 1968

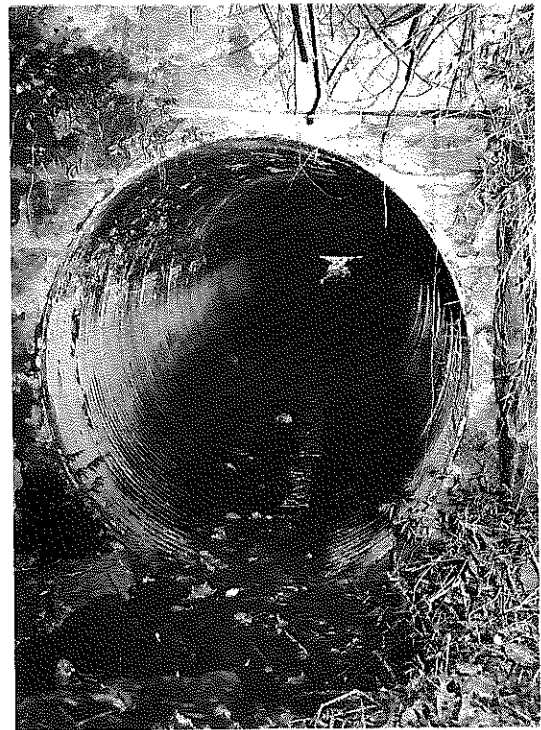
The first BCCM pipe in Kentucky was installed 5.8 miles east of Jackson, KY 15, near Haddix, in 1928. An existing masonry, box culvert with a concrete slab roof was failing. An 84-inch diameter, full-coated, paved invert, one-dip pipe was threaded into the existing box in the fall of 1928. Figure 1 shows the pipe soon after installation. Saunders Threlkeld (Junior Materials Engineer), reporting on a group inspection, July 14-16, 1941, noted some loss of coating at the outlet. Figure 2 shows the culvert as it was in October 1951. The coating was quite shrunken, and some was missing in the lower half, nearest the ends. The water was found to be altogether inoffensive. KY 15 was reconstructed in 1967.
